**SANTA MARIA PUBLIC AIRPORT DISTRICT
BOARD OF DIRECTORS**

**REGULAR MEETING
A G E N D A**

MINUTES OF THE REGULAR BOARD
MEETING OF THE BOARD OF DIRECTORS
OF THE SANTA MARIA PUBLIC AIRPORT
DISTRICT HELD SEPTEMBER 24, 2020

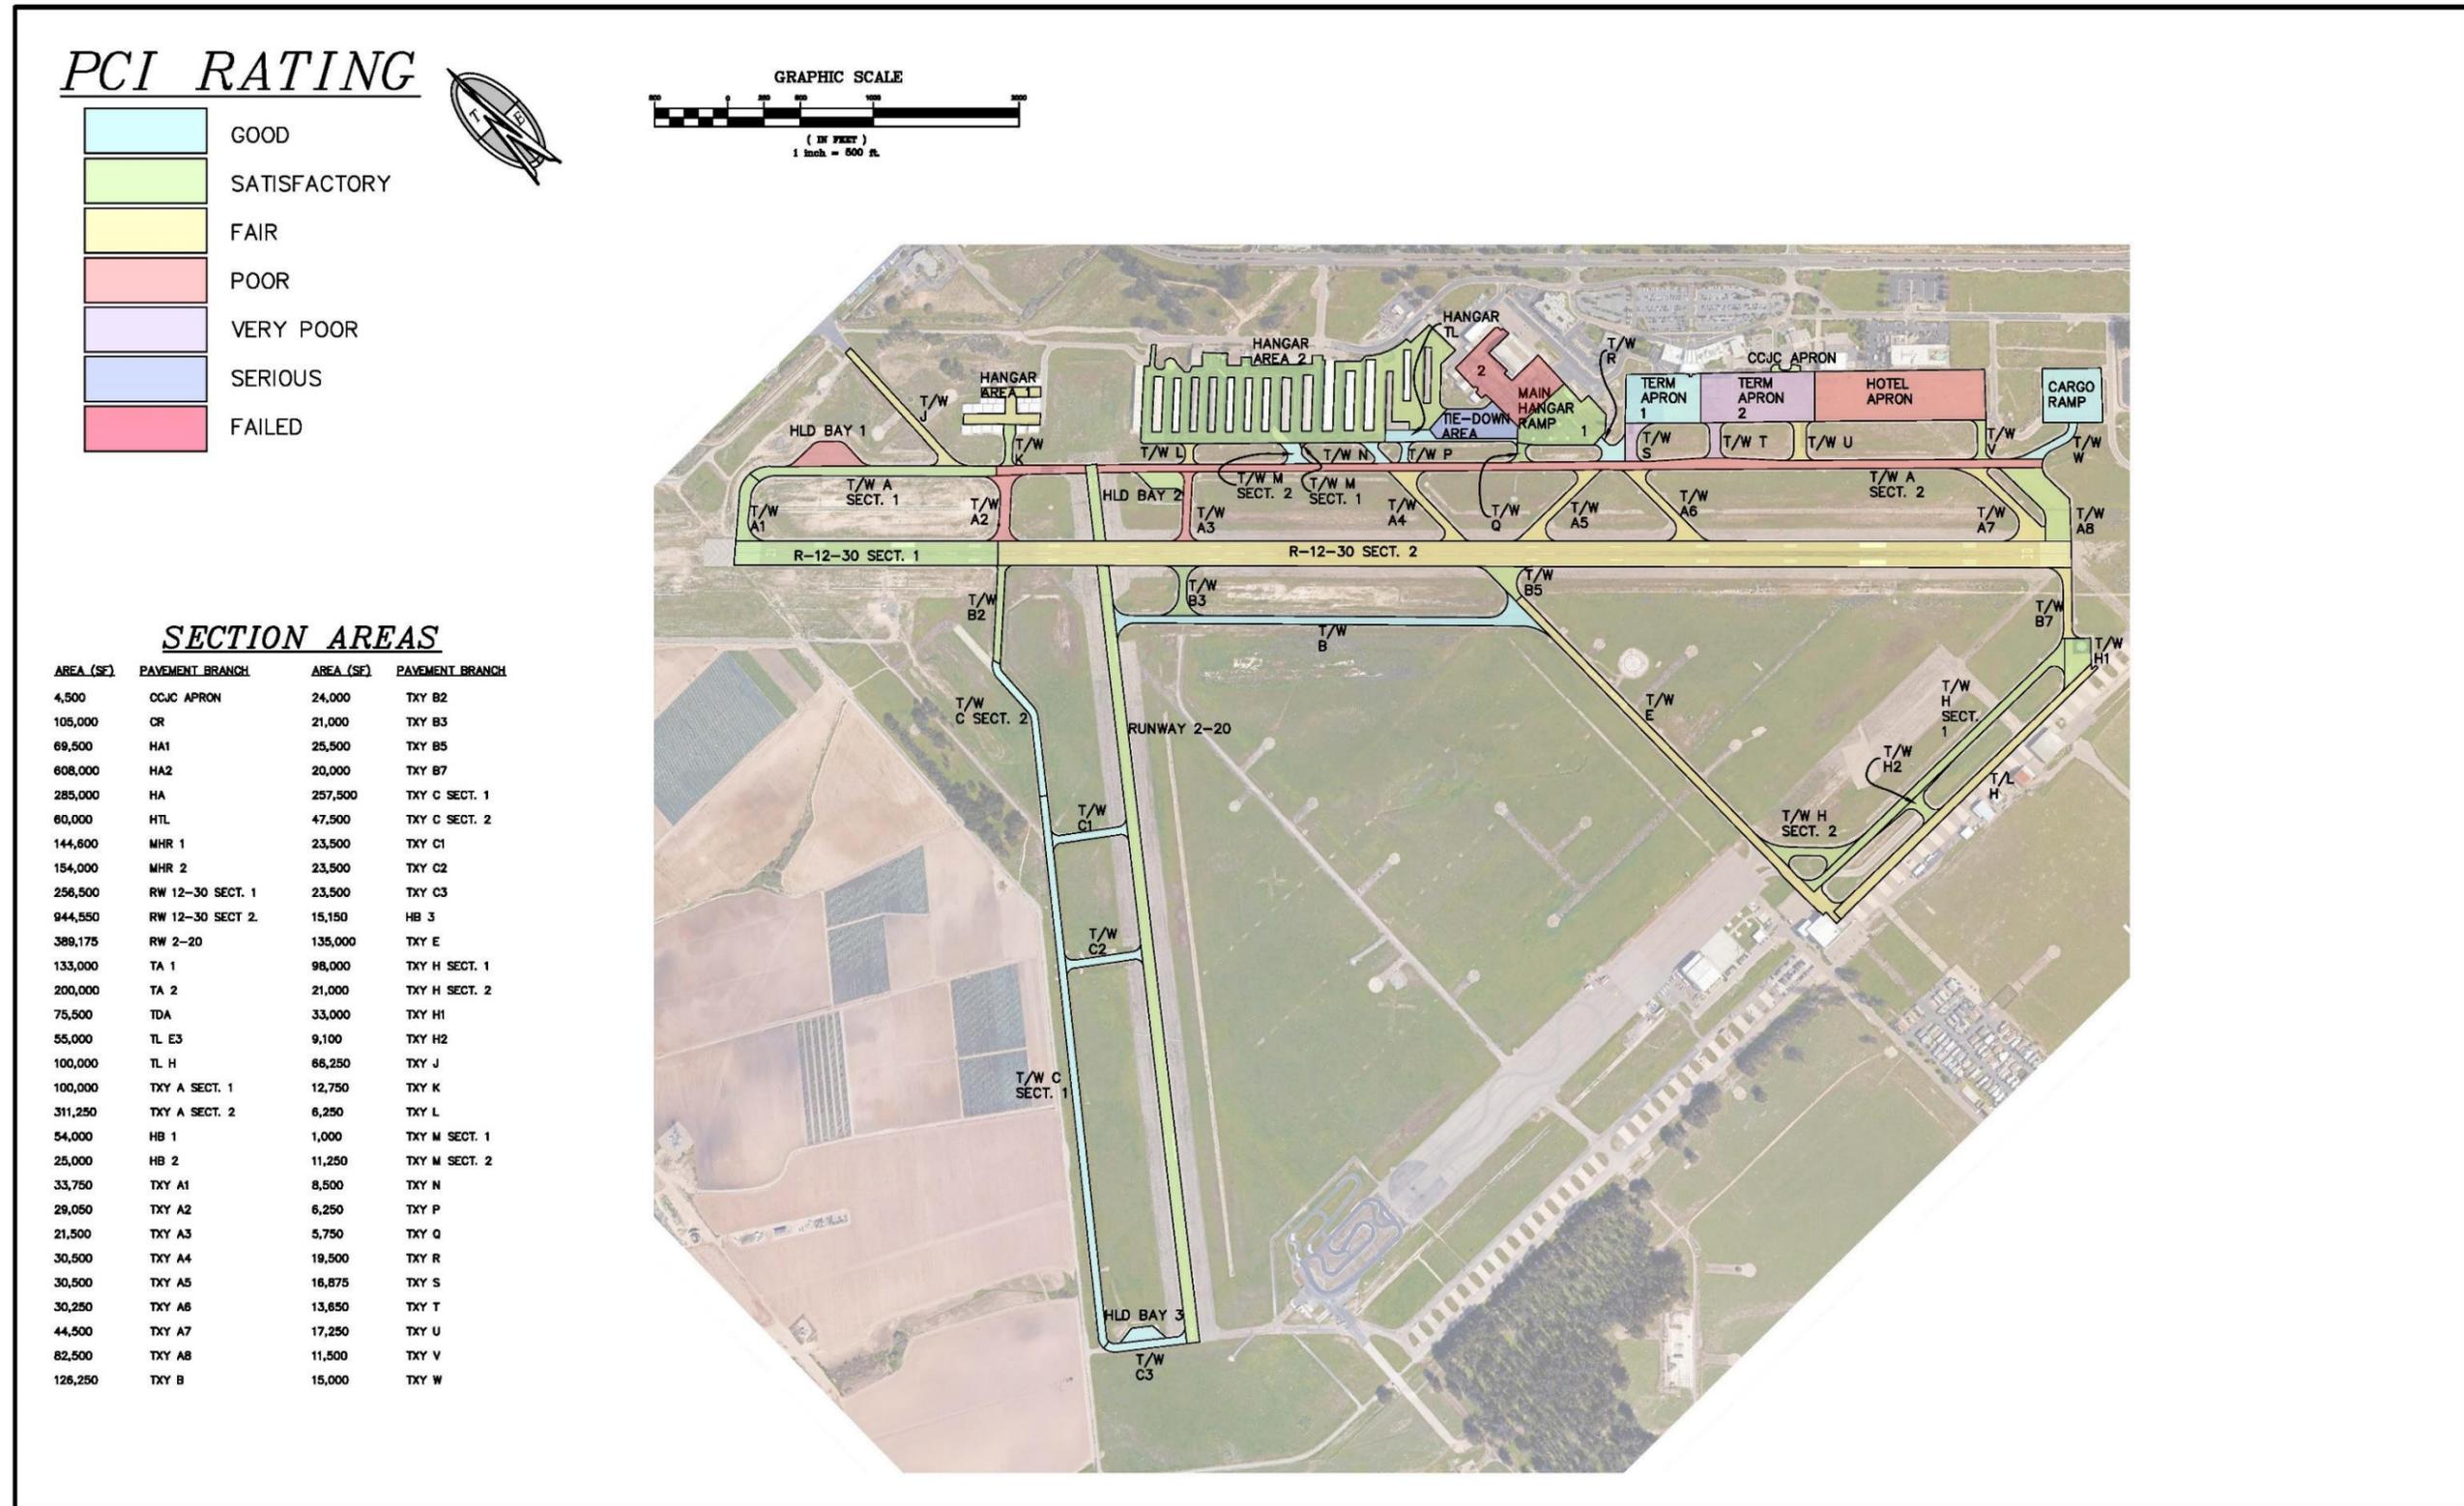
FIGURE 2: Santa Maria Public Airport PCI Rating Map

Having completed the visual inspection portion of the analysis, the team then focused its efforts on determining a numerical value for the condition of the sample unit inspected. Using PAVER 7 software, the Pavement Condition Index (PCI) was calculated for each individual section based on the results of the field inspection. The summary of each distress type and severity for each section is listed in TABLE 4, Pavement Section Distress Summary. The PCI results for each section are shown in TABLE 5, Section Condition Report, and graphically depicted on FIGURE 2, Santa Maria Public Airport PCI Rating Map. The following displays the pavement condition based on calculated PCI:

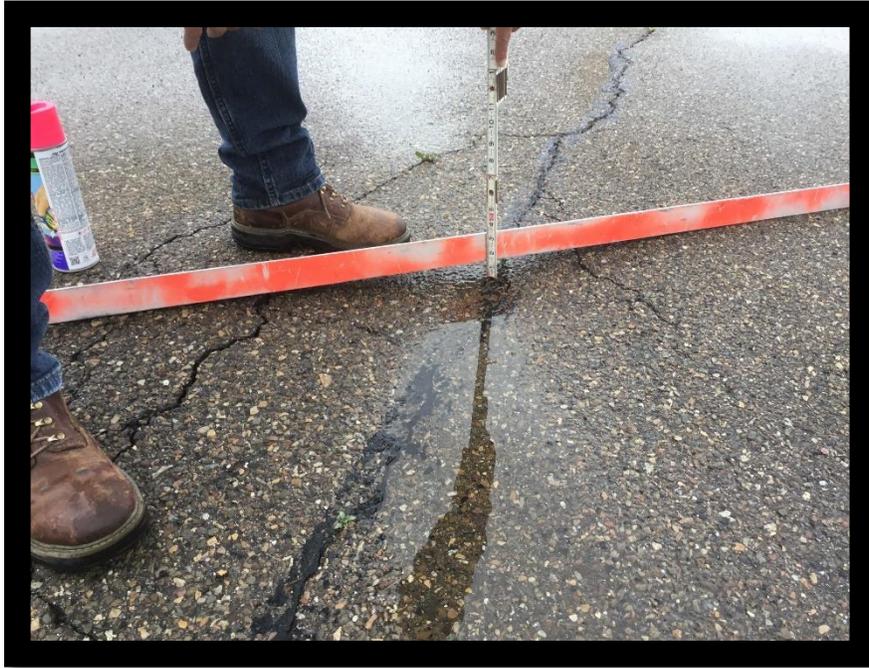
TERMINAL APRON, SECTION 2, SAMPLE UNIT 18 – Distress Type: Rutting

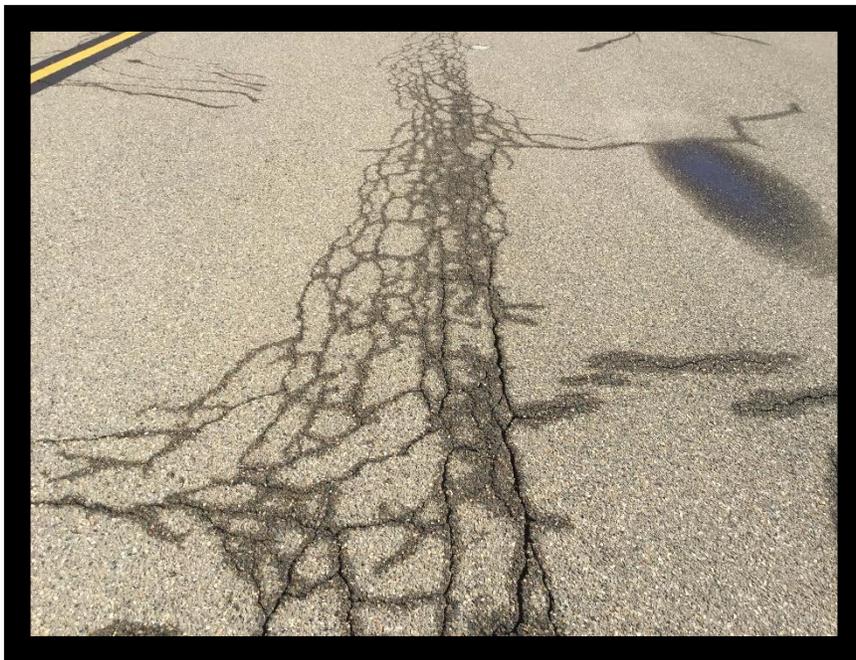
TAXIWAY T, SAMPLE UNIT 2 – Distress Type: Alligator Cracking
